Massachusetts Department of Environmental Protection
Bureau of Resource Protection – Watershed Permitting Program
Sanitary Sewer Overflow (SSO)/Bypass
Notification Form

Hull, MA WPCF

Unauthorized Discharge Summary 148 Atlantic Ave. Pump Station #1 [08-26-19]

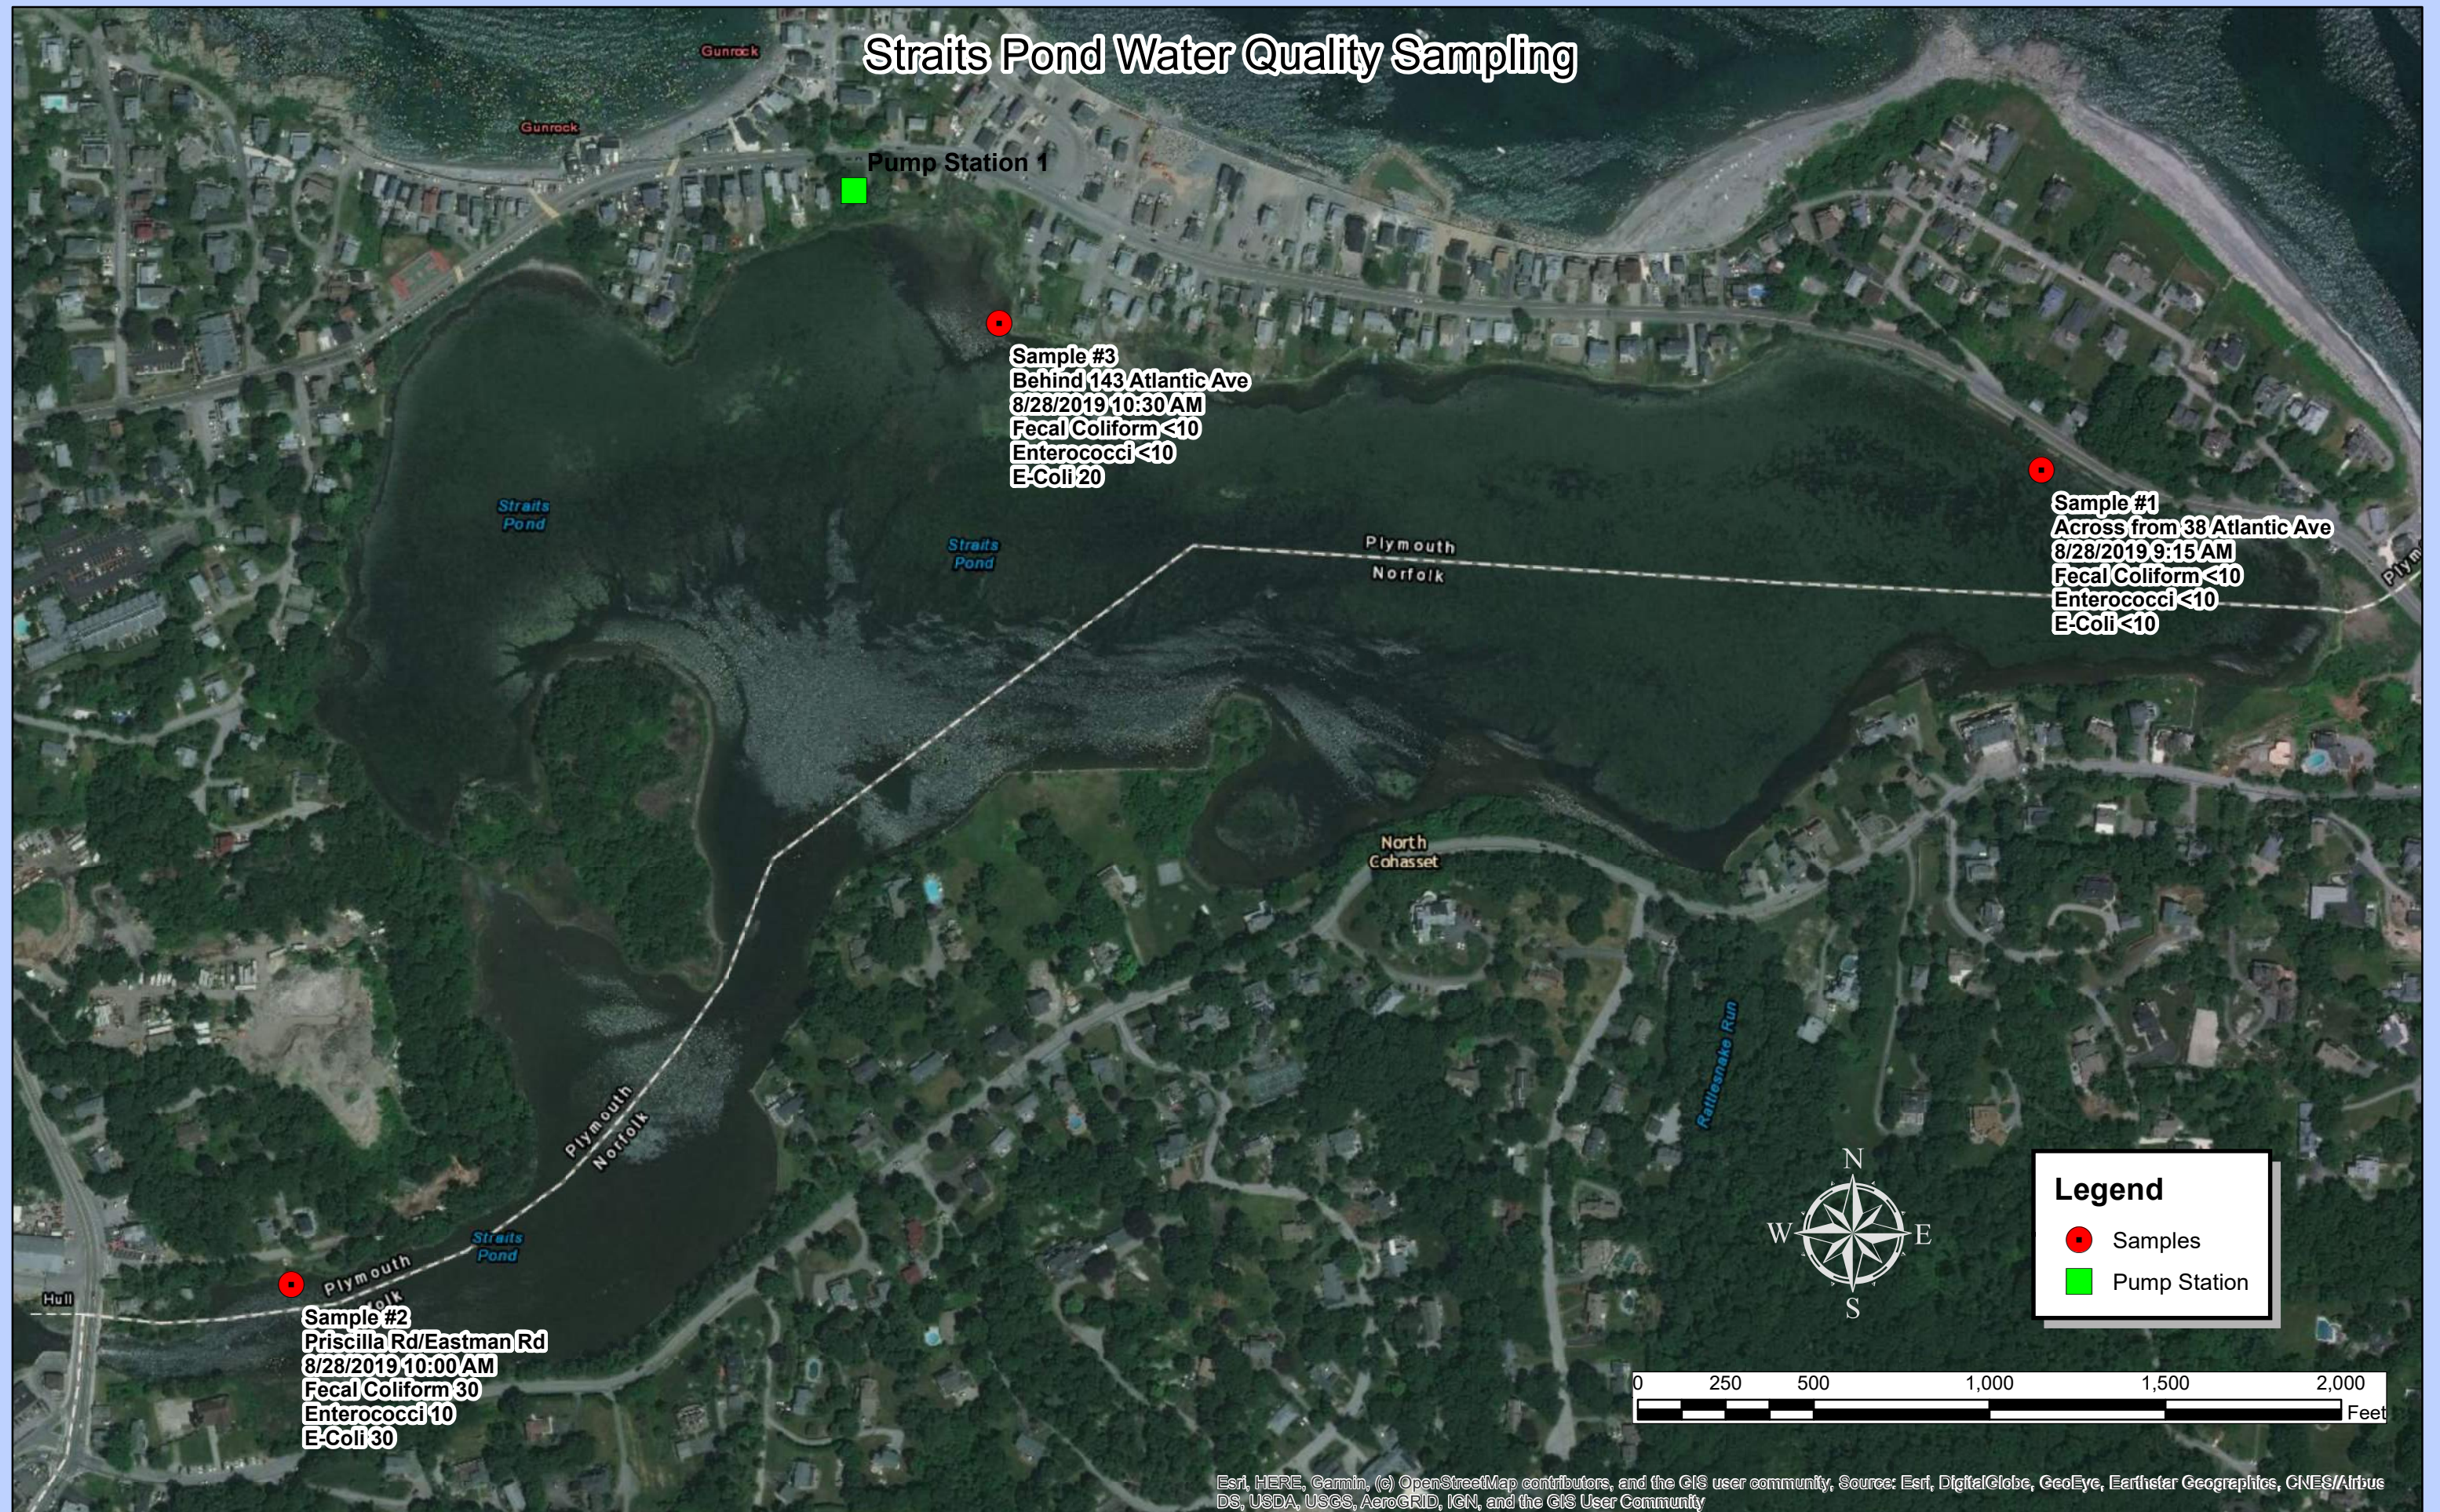
Straits Pond Water Quality Sampling

See attached pictures, Supplemental "Unauthorized Discharge Summary" and maps of area. Sampling results
noted on the map of Straits Pond.
